CUSTOMER CASE STUDY

\$800k Compressor Repair Avoided with AI

Specialty Gas Manufacturer Saves Big by Using AI to Optimize Compressor Maintenance Schedule

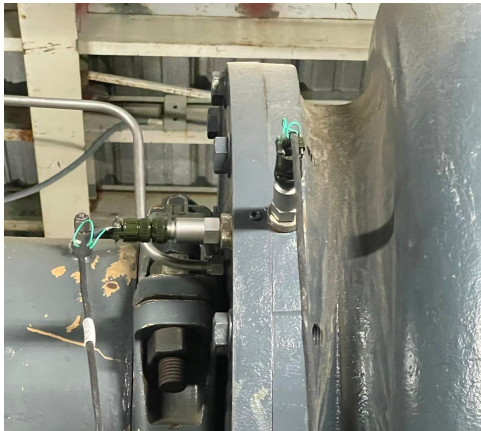
Two X, Y, Z axis accelerometer sensors were installed on each stage of the compressor, and data was transmitted to a gateway and a user interface in the cloud. Paul Chen, a Level 3 vibration analyst, set thresholds for each vibration sensor according to ISO 10816-3 standards.

X, Y, Z vibration sensors mounted on compressor

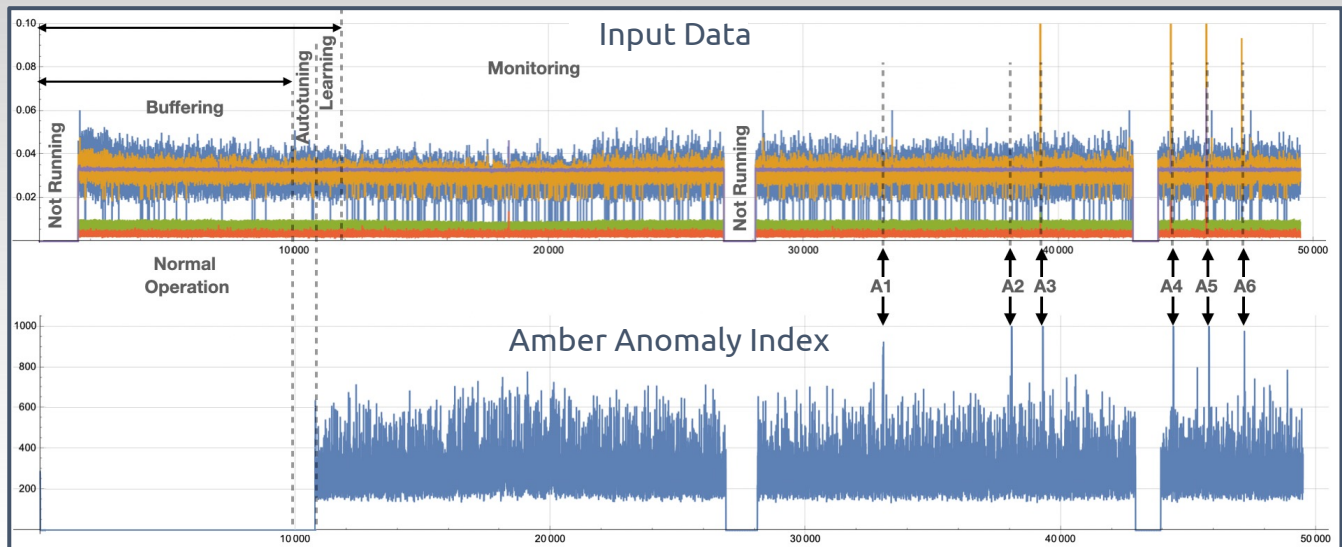
Threshold vs. Relational Anomaly Detection

Six anomalies in the data are shown as A1 through A6. A3 through A6 are anomalies that can be detected using traditional threshold-based techniques. Anomalies A1 and A2 are relational anomalies only visible to Amber's high-dimensional model, meaning earlier detection of noncompliant behavior.

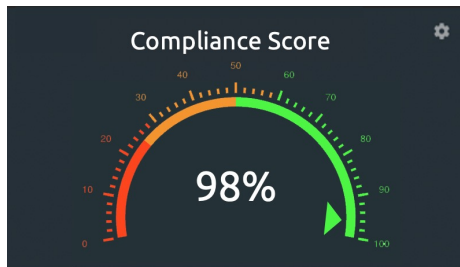
January 6th: Amber completed training and started monitoring real-time data. In monitoring mode, Amber returns a Compliance Score and a Feature Significance value for each sample of data processed. At the start of monitoring, the Compliance Score was 98%, meaning that the asset's operating behavior was very similar to that which Amber had learned during training.

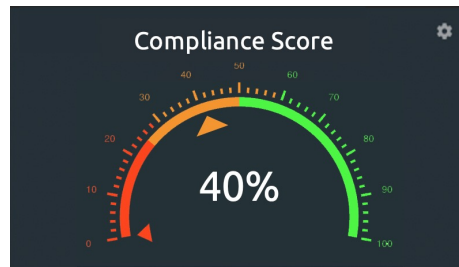
January 29th – February 11th: The Compliance Score decreased, eventually falling below 40% and indicating that the compressor was in a new, never-before-seen operating state. Meanwhile, Paul's threshold-based monitoring system showed no issues.

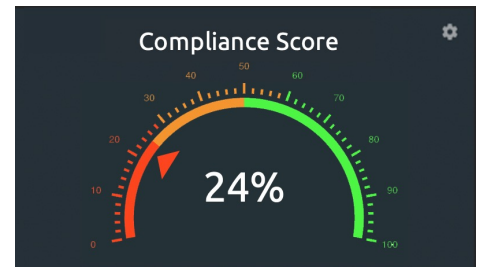
March 9th: The Compliance Score had decreased to 24%, signifying that the problem with the compressor was critical. Staff members onsite were notified of the score and the associated Feature Significance values, which pointed to Stage 3 of the compressor. A work order was created for maintenance on March 13th.

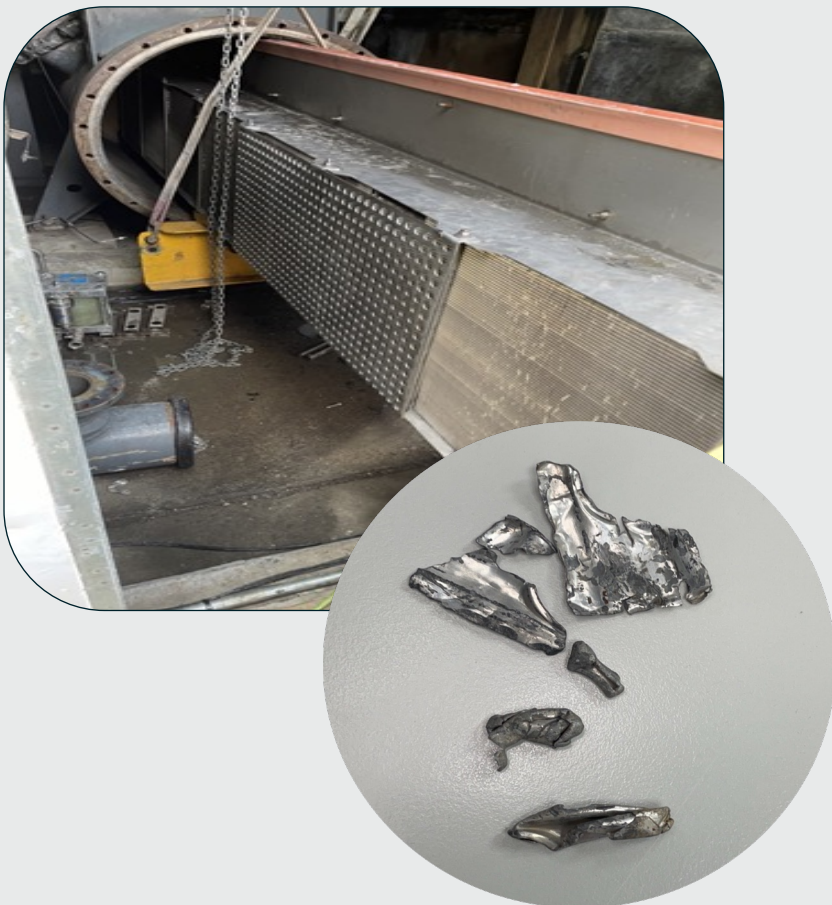
Images of Compressor Breakage

On **March 13th**, two maintenance technicians inspected Stage 3 of the compressor. No obvious problems were noted during an initial overview, but upon closer inspection the technicians noticed a few small cracks on the cooling bundle. After further investigation, several tears were found on the cooling fin.

Pieces of aluminum from the cooling fin

Had the breakage gone undetected, replacement of the core unit would have been required, costing over \$800,000. Thus, Amber was successfully used to substantially reduce maintenance costs for this event.

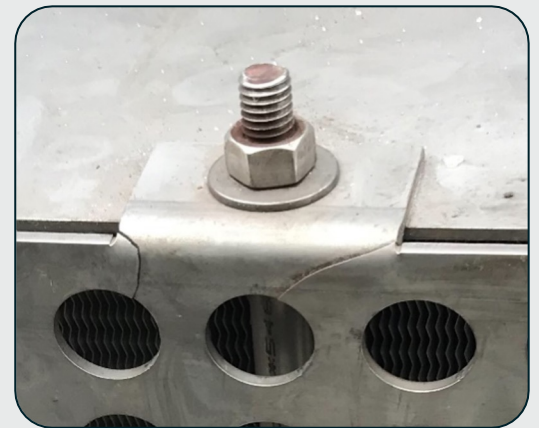
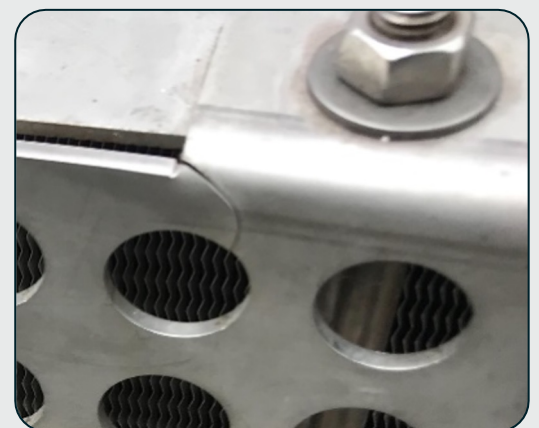
Cracks on the cooling bundle

"Amber alerted our staff members that they needed to stop and repair the compressor, which they did three months earlier than originally planned. That allowed them to see several cracks on their cooling bundle that, if left unrepaired, could have caused \$800,000 in repair costs. Instead, they spent \$60,000 to repair the cooling bundle and were up and running in 72 hours."
